AMMRC TR 71-59

OXIDATION BEHAVIOR OF A  
COMPLEX DISILICIDE COATING-  
Ta-10W ALLOY SYSTEM AT  
TEMPERATURES OF 1700 TO 2700 F

MILTON LEVY and JOSEPH J. FALCO  
METALS DIVISION

December 1971

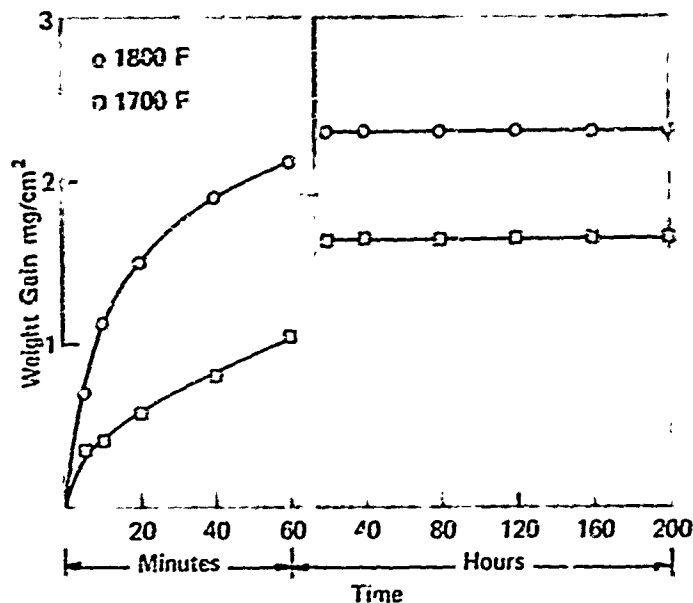
19-066-1024/AMC-71

Figure 3. OXIDATION CURVES OF A COATED REFRACTORY ALLOY IN THE TEMPERATURE RANGE OF 1700 F TO 1800 F.

At 1700 to 1800 F, Figure 3, oxidation proceeds parabolically for the first few hours after which it exhibits no further weight gain. This indicates that the protective film formed over the coating during the initial oxidation is maintained throughout the entire run of 200 hours. Figure 4 is a photograph of the coated alloy oxidized at 1700 F for 20 minutes in air. A cracking pattern is observed in the lighter areas. It has been amply demonstrated that large stresses are present in metal-oxide systems during and after oxidation which can

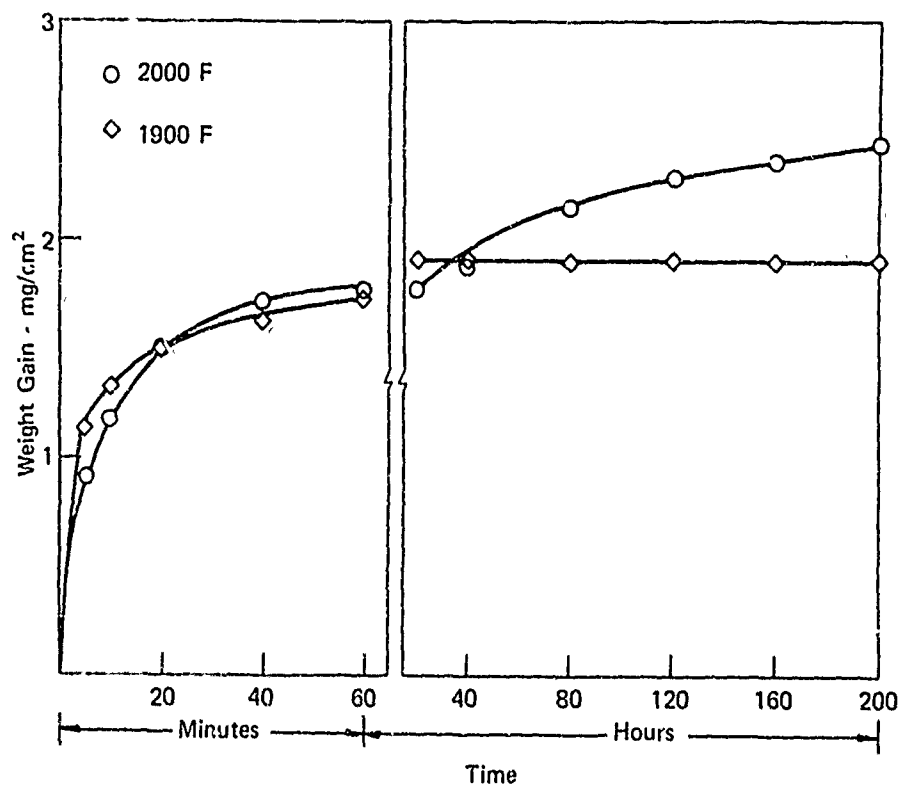
Figure 6. OXIDATION CURVES OF A COATED REFRACTORY ALLOY IN THE TEMPERATURE RANGE OF 1900 F TO 2000 F. 19-066-1023/AMC-71

Figure 6 contains oxidation curves at 1900 and 2000 F where the initial segments of both curves are parabolic followed by linear portions. At 1900 F, the linear portion represents no further weight gain; while at 2000 F, there is an increase in weight. In both cases, complete protection is afforded the substrate alloy for 200 hours.

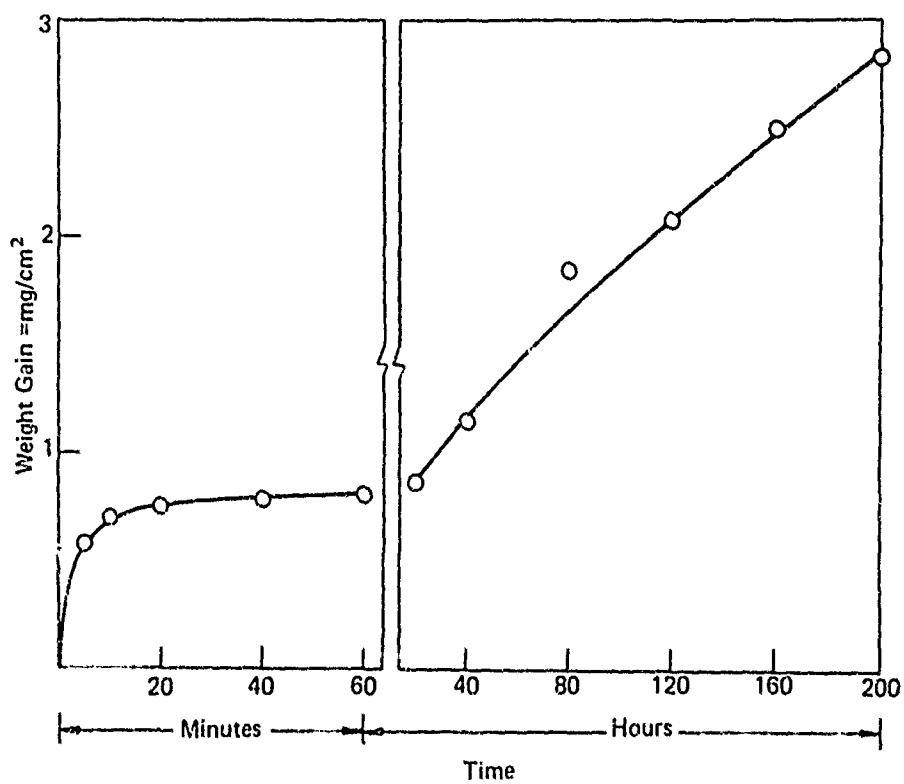
Figure 7. OXIDATION CURVE OF A COATED REFRACTORY ALLOY AT 2100 F. 19-066-1022/AMC071

Figure 7 shows that oxidation at 2100 F follows the parabolic growth law, and complete protection is afforded the substrate alloy by the coating. Some volatilization of oxidation products may be occurring at this temperature since the initial oxidation rate is less than observed at 2000 F. At this temperature (2100 F) the outer protective layer first takes on a glazed appearance. Fitzer<sup>2</sup> reports that disilicide coatings for molybdenum take on this glassy appearance at 2400 F. The lower temperature we report may be due to the complex composition of our coating system. In addition to Mo and Si, the coating contains Ti, V, and W which may lower the melting point of the glassy-like compounds formed and have the beneficial effect of allowing self-healing to take place at lower temperatures.

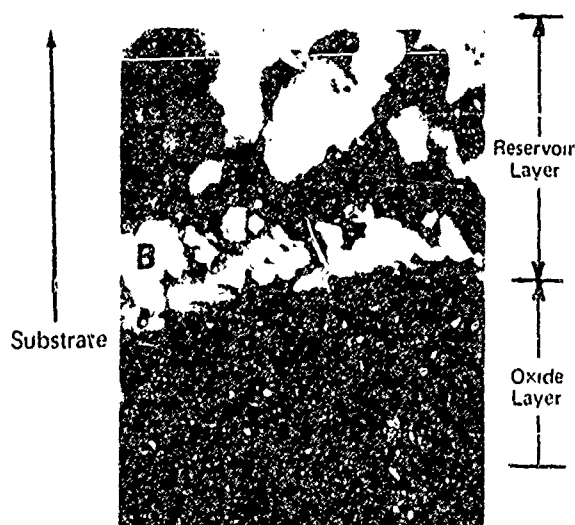
19-066-941/AMC-71

Figure 9. MICROPROBE ANALYSIS OF COATED REFRACTORY ALLOY AFTER 200 HOURS OF AIR OXIDATION AT 2100 F. Mag. 1000X.

Point	Identification	Si	Ta	W	Mo	Ti	V
B	TiO <sub>2</sub>	4.5	0.3	8.7	<0.1	35-40	0.4
C		20-25	<0.1	9.0	<0.1	1.2	<0.1
D	SiO <sub>2</sub>	40-50	0.1	0.9	<0.1	1.4	0.8

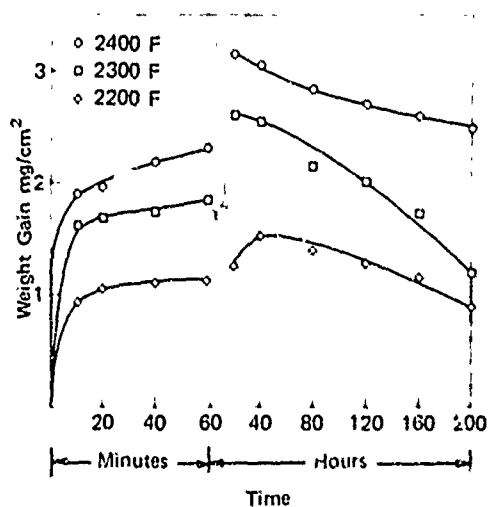
19-066-1021/AMC-71

Figure 10. OXIDATION CURVES OF A COATED REFRACTORY ALLOY IN THE TEMPERATURE RANGE OF 2200 F TO 2400 F.

In this temperature range, oxidation rates increase with increasing temperature as shown in Figure 10. At each temperature, after one hour of oxidation, the oxidation rates decrease with time, particularly at 2300 F probably due to volatilization. Spectrographic analysis of the effluent gases, which were passed through a scrubber containing 10% Na OH, showed that silicon was present in fairly large amounts and Mo, W, and V in lesser amounts and Ti in a trace amount. The electron microprobe analysis for the coated alloy oxidized at 2300 F shown

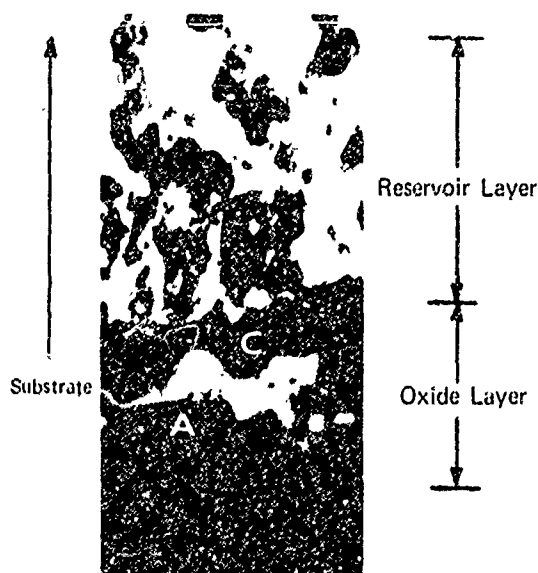
19-066-942/AMC-71

Figure 12. MICROPROBE ANALYSIS OF COATED REFRACTORY ALLOY AFTER 200 HOURS OF AIR OXIDATION AT 2300 F. Mag. 500X.

Point	Identification	Si	Ta	W	Mo	Ti	V	Distance $\mu$
A	SiO <sub>2</sub>	20-25	0.1	3.1	0.1	2.6	0.4	270
B	TiO <sub>2</sub>	1.0	0.3	4.3	0.3	55-60	0.3	265
C	SiO <sub>2</sub>	35-40	0.1	0.1	0.1	2.9	0.1	260

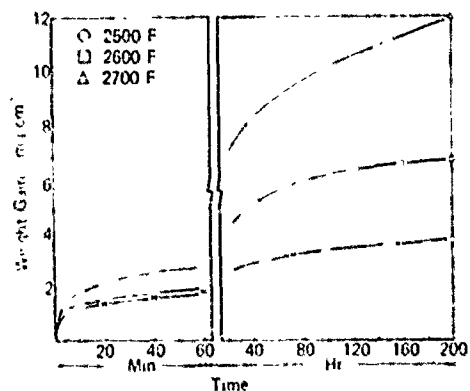
19-066-175/AMC-70

Figure 13. OXIDATION CURVES OF A COATED REFRACTORY ALLOY IN THE TEMPERATURE RANGE OF 2500 F TO 2700 F.

Figure 13 shows that the parabolic rate law still holds in the range 2500 to 2700 F, and oxidation rates increase with increasing temperature. The marked increase in oxidation rate at 2700 F after the first hour indicates that the protective limit of the coating is being approached. However, complete protection was afforded the substrate alloy for the entire run. Some volatilization has probably occurred but is considered to be minor since a net weight gain of 12 mg/cm<sup>2</sup> at 2700 F is noted. This relatively small change in weight again attests to the excellent protective properties of the coating system.

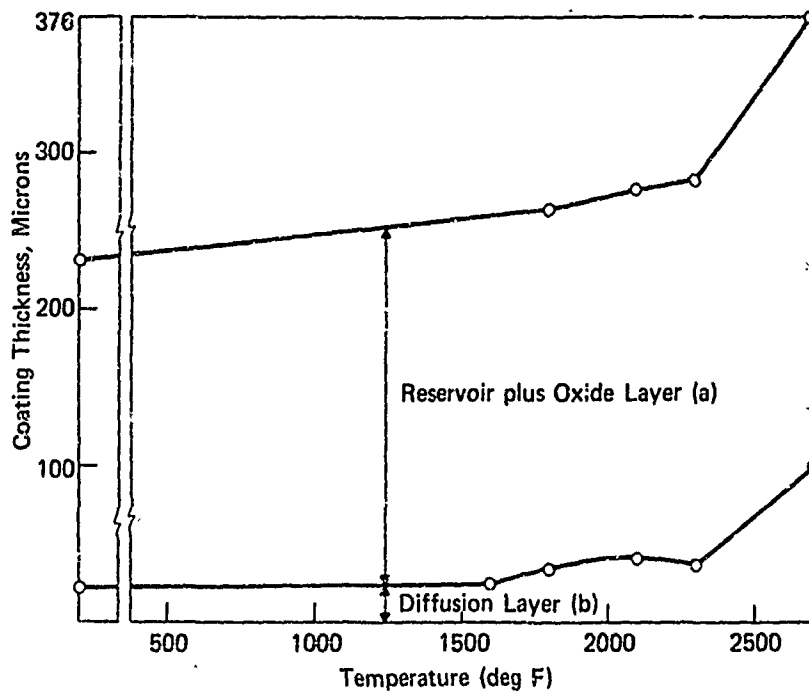
Figure 16. CHANGE OF COATING THICKNESS WITH TEMPERATURE.  
19-066-943/AMC-71

reservoir (porous) and outer protective layers vary with temperature after 200 hours of oxidation. Both coating layers generally increase in thickness with increasing temperatures, particularly above 2300 F.

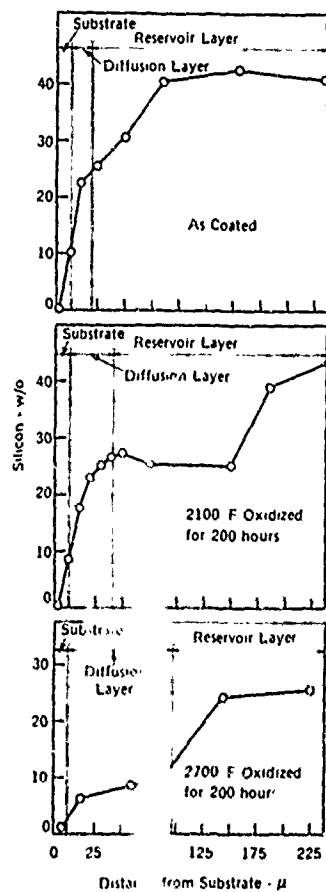
19-066-1020/AMC-71

Figure 17. DIFFUSION OF SILICON IN THE COATING SYSTEM

Figure 17, the plot for silicon, shows that the silicon concentration decreases in both reservoir layer and diffusion layer and at the interface between substrate and diffusion layer as the coated alloy is oxidized at 2100 and 2700 F. Some silicon has penetrated into the substrate alloy at 2700 F.

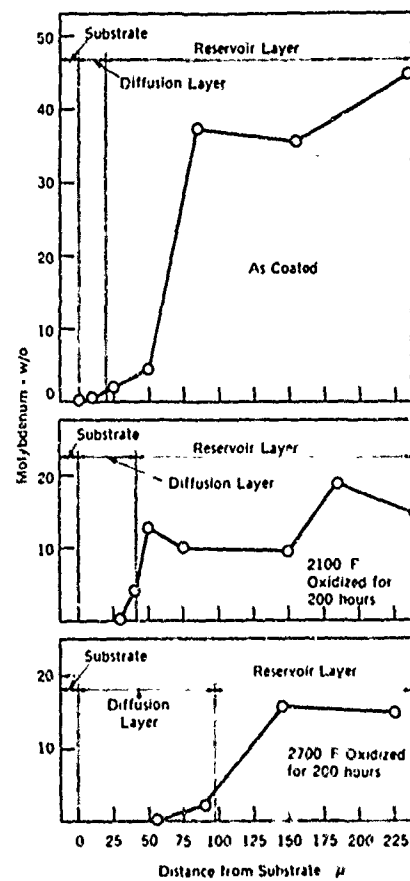
19-066-1019/AMC-71

Figure 18. DIFFUSION OF MOLYBDENUM IN THE COATING SYSTEM

The molybdenum plot, Figure 18, shows that molybdenum concentrations as high as 45 wt % were present in the as-coated condition in the reservoir layer. After oxidation, the molybdenum concentration decreased markedly in the reservoir layer. There was little effect in the diffusion layer where the molybdenum concentration was low, and none was present at the interface of substrate and diffusion layer.

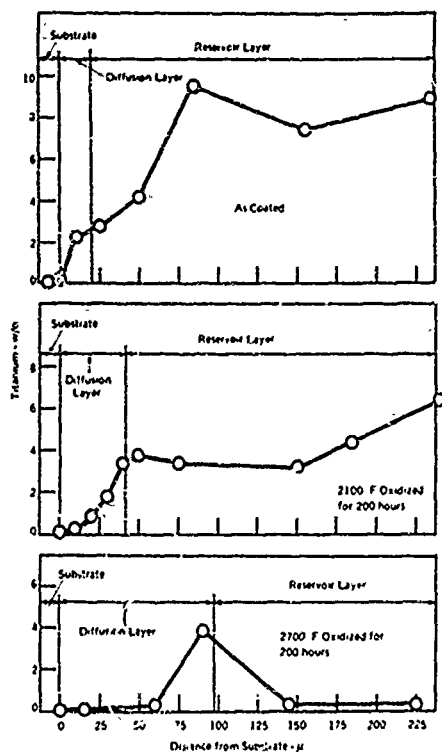
19-066-1018/AMC-71

Figure 19. DIFFUSION OF TITANIUM IN THE COATING SYSTEM

Titanium also decreases significantly in the reservoir layer as a result of oxidation (see Figure 19). There was a slight increase of titanium in the diffusion layer and only very small amounts were present at the substrate-diffusion layer interface. At 2700 F, the titanium clusters at the interface between the diffusion and reservoir layers. Figure 20 shows that vanadium behaved similarly to titanium.

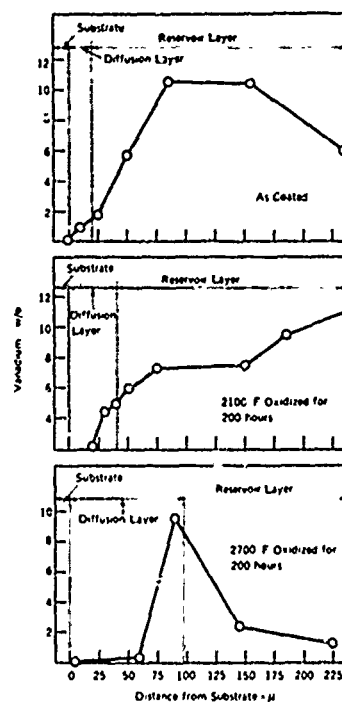
19-066-1017/AMC-71

Figure 20. DIFFUSION OF VANADIUM IN THE COATING SYSTEM

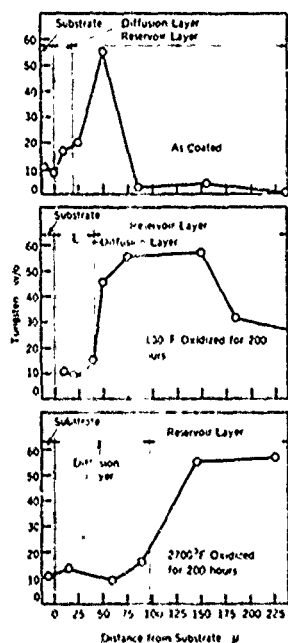
19-066-1016/AMC-71

Figure 21. DIFFUSION OF TUNGSTEN IN THE COATING SYSTEM

In the as-coated condition, tungsten is concentrated in the reservoir layer close to the diffusion layer, also in the diffusion layer and, of course, it constitutes 10% of the substrate alloy (see Figure 21). Oxidation causes the tungsten to be more uniformly dispersed in the reservoir layer (55%), while the amount of tungsten in the diffusion layer decreases. Therefore, tungsten is diffusing from the diffusion layer into and throughout the reservoir layer.

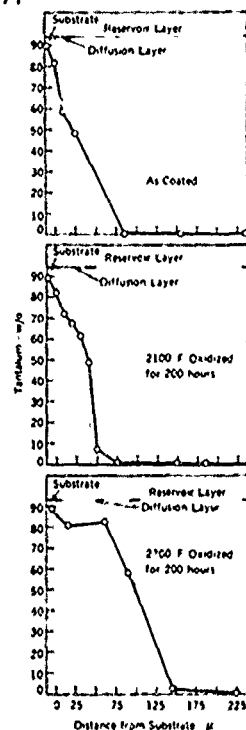
19-066-1015/AMC-71

Figure 22. DIFFUSION OF TANTALUM IN THE COATING SYSTEM

Figure 22 shows that tantalum, in the as-coated and under oxidizing conditions clusters mainly at the substrate/diffusion layer interface, and in the diffusion layer. At 2700 F, there is some diffusion of tantalum (0.9 wt %) up to 225 $\mu$  from the substrate into the reservoir layer. Diffusion of tantalum from the substrate into the diffusion layer contributes to the broadening of the diffusion layer noted at 2700 F.

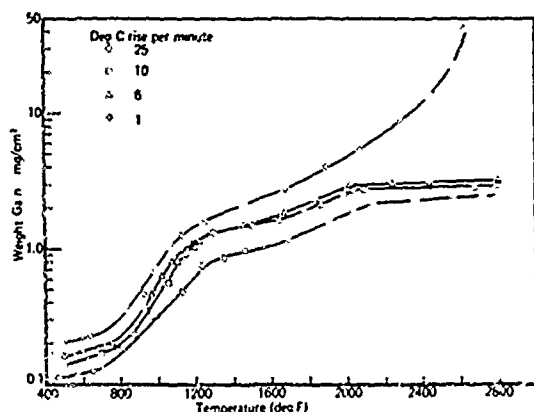
Figure 23. EFFECT OF HEATING RATES ON THE OXIDATION OF A COATED REFRACTORY ALLOY FROM ROOM TEMPERATURE TO 2800 F.  
19-066-176/AMC-70

Since we reported<sup>1</sup> that the complex disilicide coatings are susceptible to peeling in the temperature range 1400 to 1600 F it seemed advisable to establish the minimum heating rate at which the coating could safely traverse the peeling range without deleterious effects. Accordingly, oxidation runs were made at heating rates of 1, 6, 10, and 25 C rise per minute from ambient to 2800 F. The results were plotted in Figure 23. Failure of the coating occurred only at the slowest heating rate of 1 C rise/minute. In the temperature range 800 to 1300 F where the slope of the curves is greatest, low temperature oxides are forming, whereas high temperature oxides are forming between 1500 and 2100 F. Since the exposure time is longer at a 1 C rise/minute heating rate at a given temperature, the opportunity for the formation of the lower temperature oxides is optimized, but failure occurs due to peeling. Therefore, higher temperature oxides must be present to alleviate peeling. Although high temperature oxides have formed to some extent during this run, it appears that damage to the intercrystalline structure of the coating during its exposure in the peeling range has progressed beyond the point where self-healing by the high temperature oxides formed can repair the damage.

High temperature oxides are completely formed at 2100 F, suggesting that this would be the most advantageous temperature to preoxidize the coating system before subjecting it to peening temperatures. A coated specimen which was preoxidized at 2100 F for 5 hours and then subjected to peening conditions afforded excellent protection for 200 hours. After 200 hours of oxidation, the coating had a uniform glazed appearance which is preferred over the specimen preoxidation treatment at 1900 F reported previously by the authors.
